BOEING
STRESS
CORROSION
TESTING
OF HIGH STRENGTH
STEELS

INVESTIGATION OF SUSCEPTIBILITY OF HIGH STRENGTH MARTENSITIC STEEL
ALLOYS TO STRESS CORROSION

TECHNICAL DOCUMENTARY REPORT NO. ASD-TDR-62-876
September 1962

(Prepared under Contract No. AF 33(616)-7839 by The Boeing Company,
Transport Division, Renton, Washington; Gary A. Dreyer, Author)

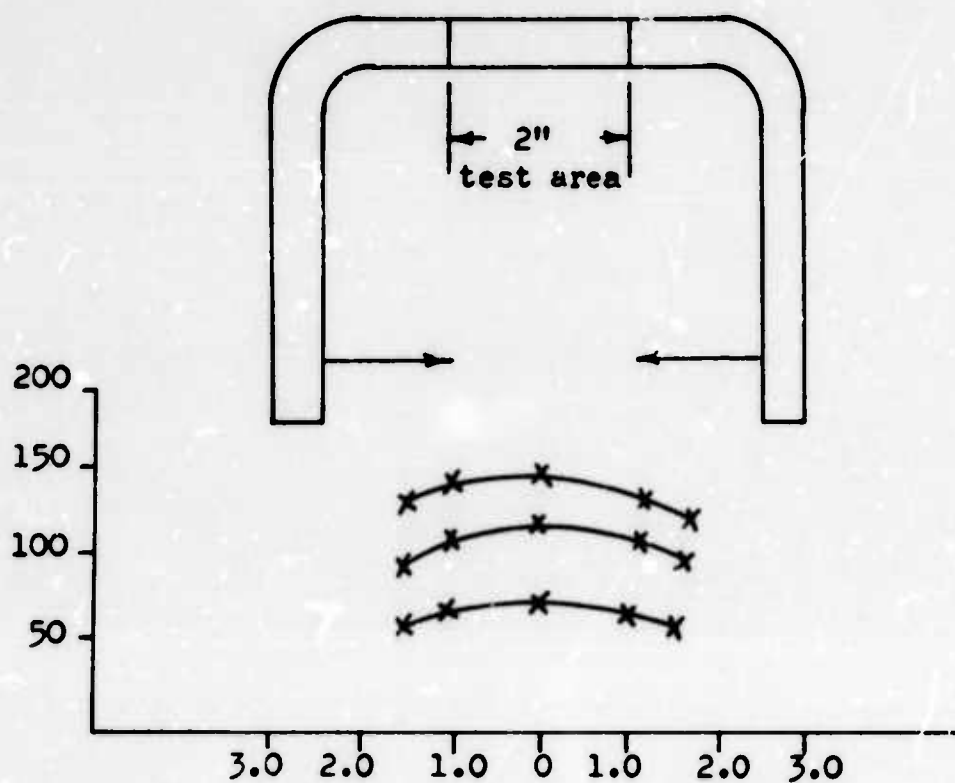
FIGURE 101. Variation in Longitudinal Bending Stress in Boeing U-Bend Specimen

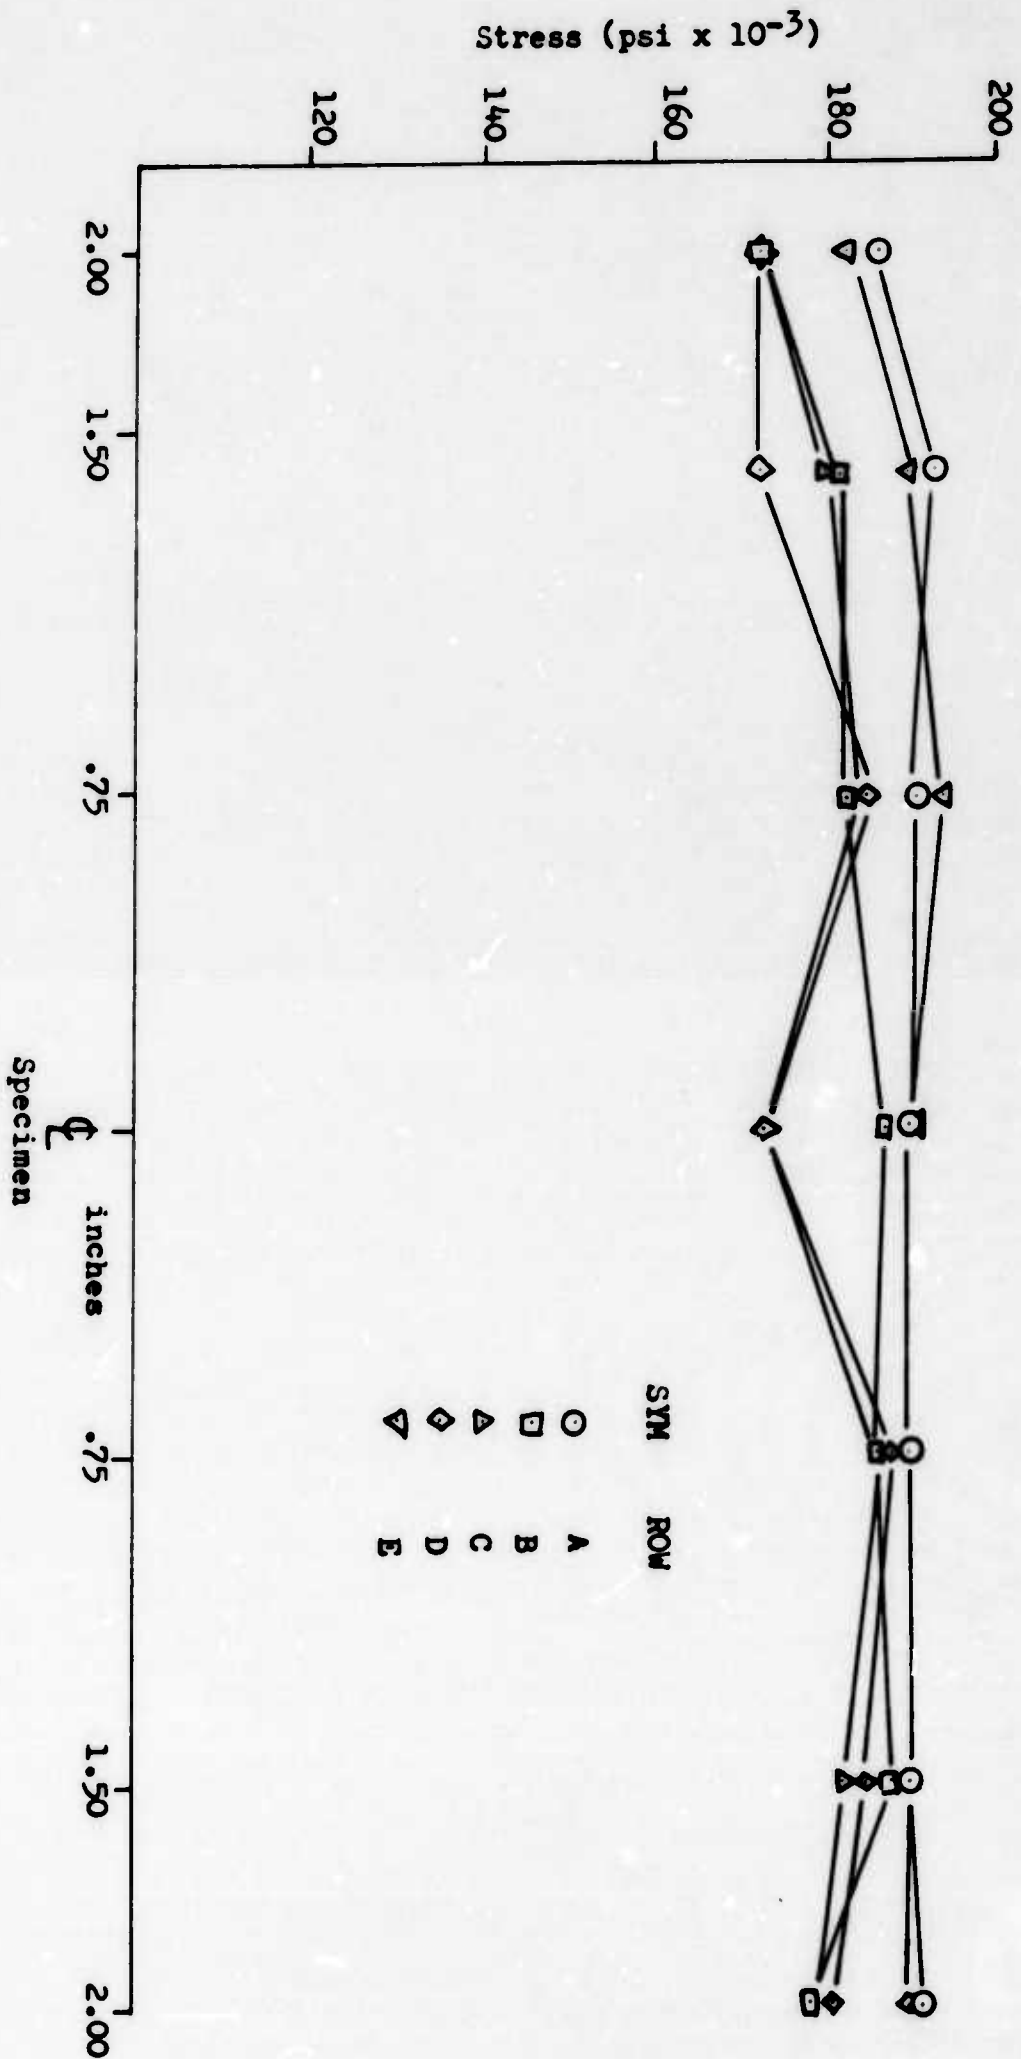
FIGURE 106. Stress Distribution Parallel to the Longitudinal Axis of the U-Bend Specimen. Symbols Refer to Locations Shown in Figure 105.

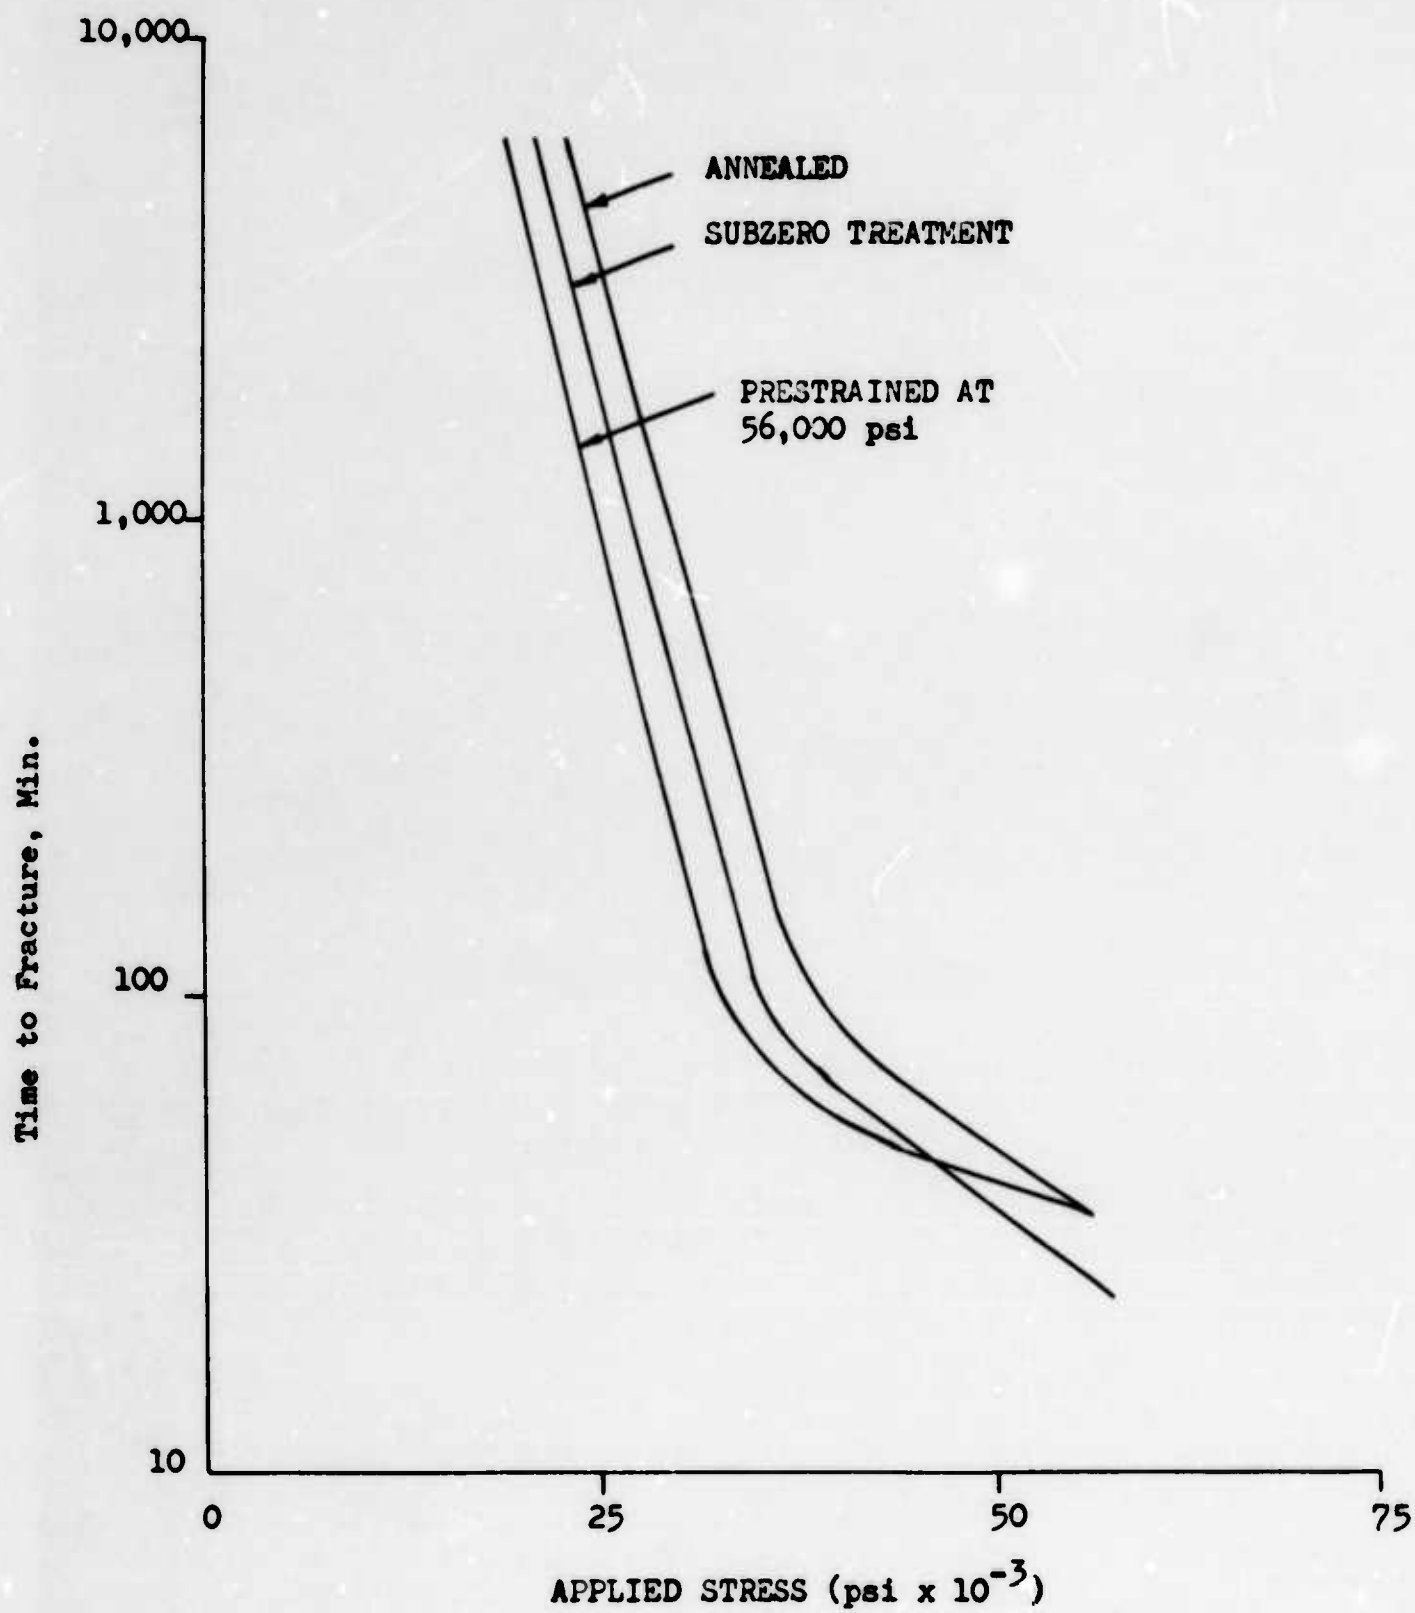
FIGURE 113. Variation of Time to Fracture with Applied Stress for 18-8 Stainless Steel

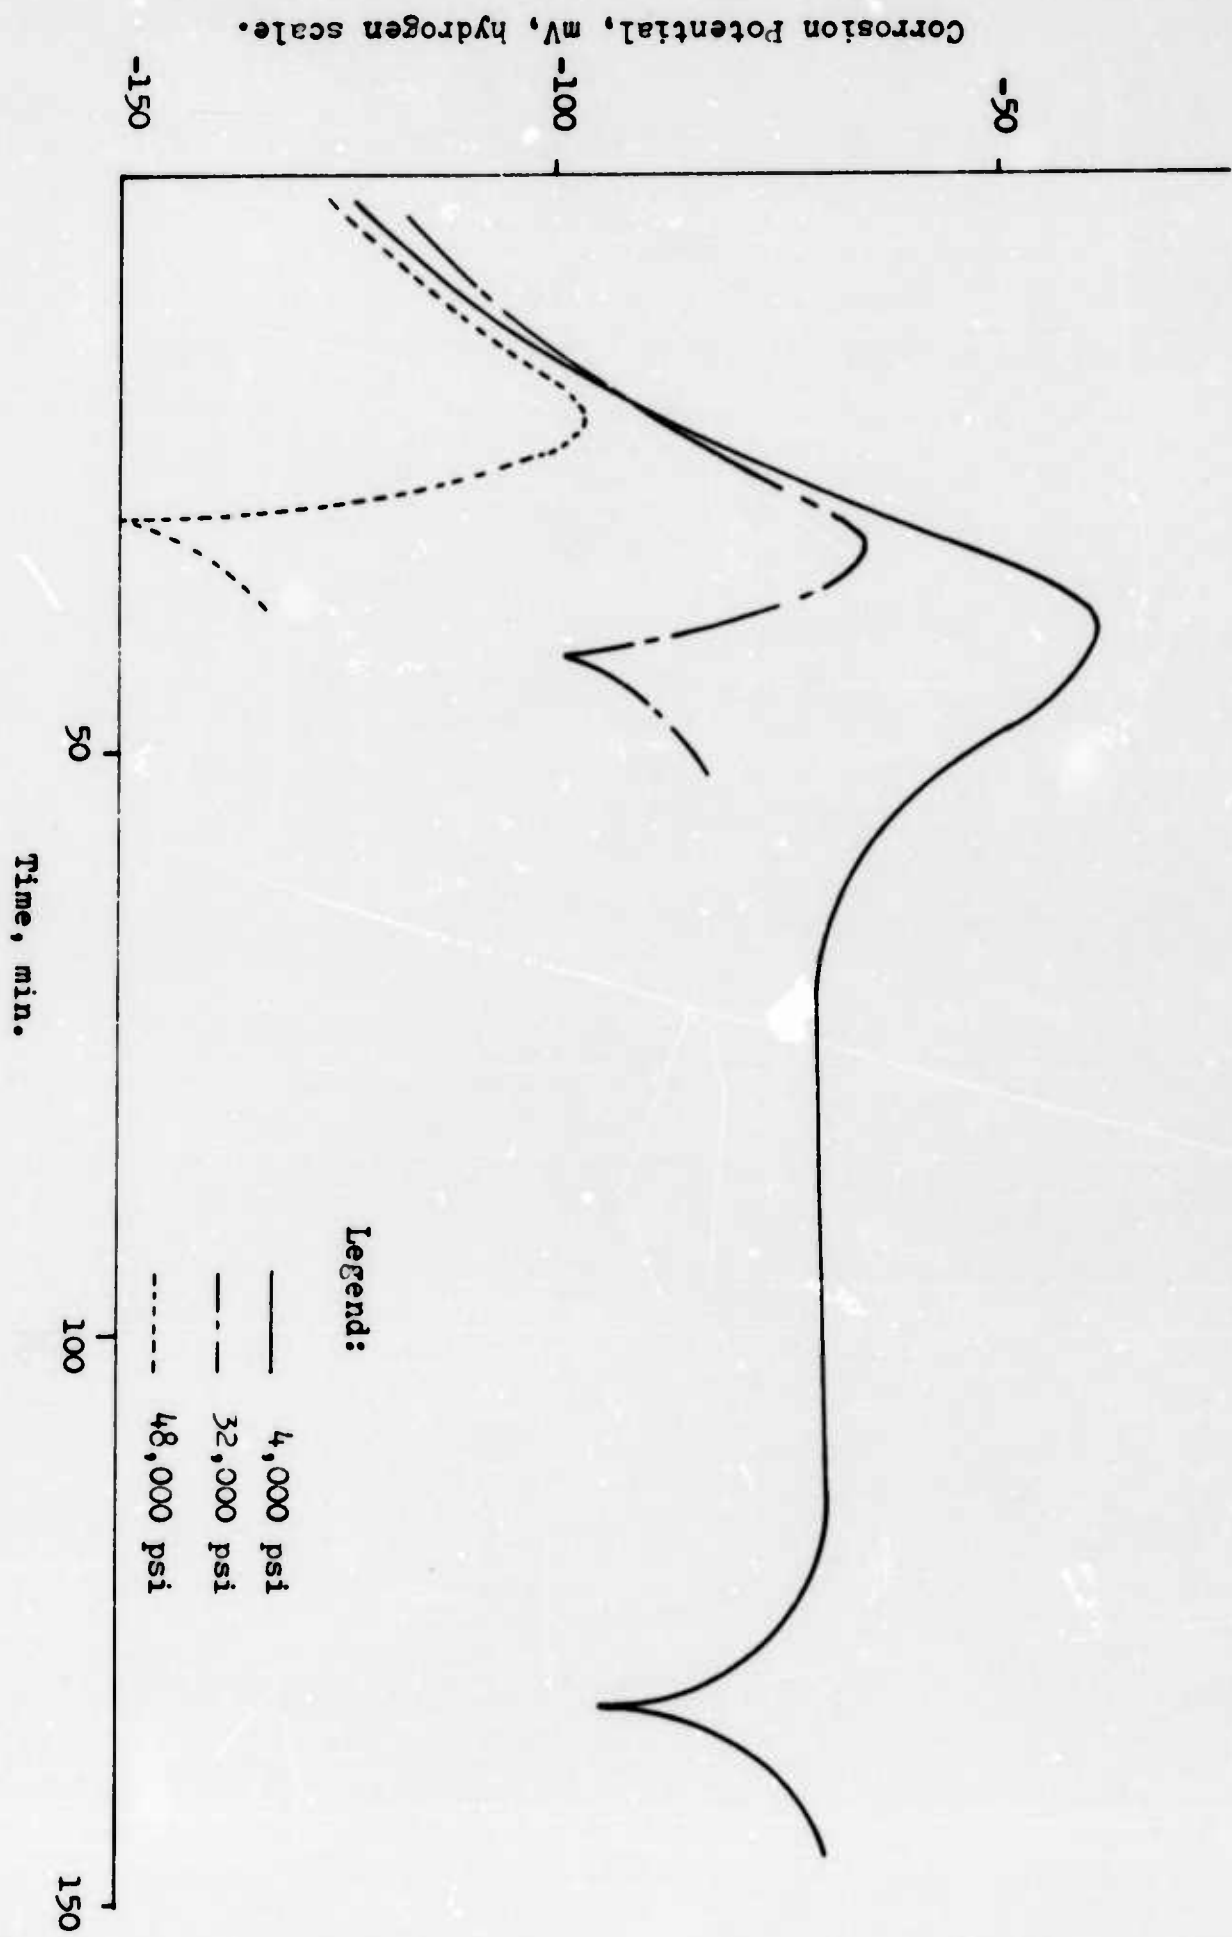
FIGURE 114. Specimen Potential Curves for 18-8 Stainless Steel
